# Enhance the Peripheral

Allen Construction resurrects a historic home following a natural disaster and upgrades the entire property to modern-day standards.

## MASTER DESIGN AWARDS 2022 HISTORIC RENOVATION GOLD

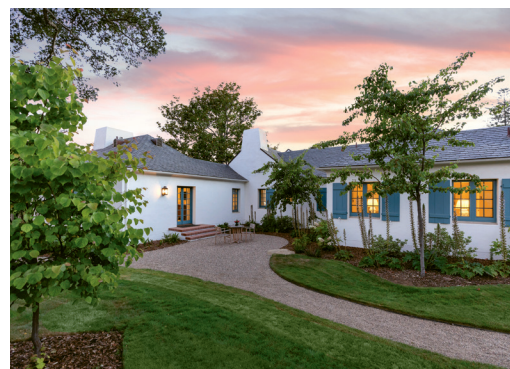
Crawlspace was limited between the east and west wings. As a result, new pipes and wires had to be run through the attic above the great room.

Upgrading all the plumbing and electrical lines proved to be a challenge because access to the crawlspace was limited between the east and west wings. What had looked to be a 3- or 4-foot opening became less than 18 inches below the living room on the other side of the house, Brown says.

“Luckily, we had a vaulted ceiling, which is a scissor ceiling, so we were able to get above it and utilize [that space] as mechanical chases.”

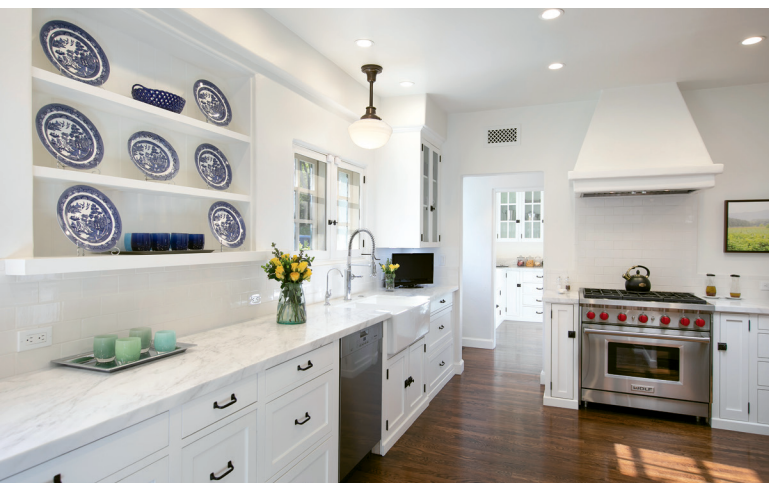
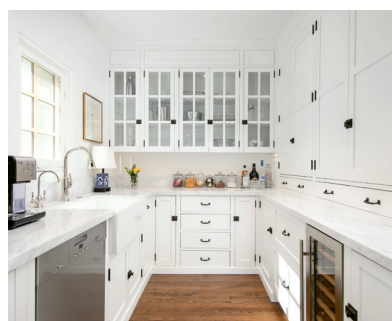
The remodel updated the kitchen counters, backsplashes and cabinets and refurbished the existing oak floors. A smaller butler's pantry (above) enabled a new laundry room.

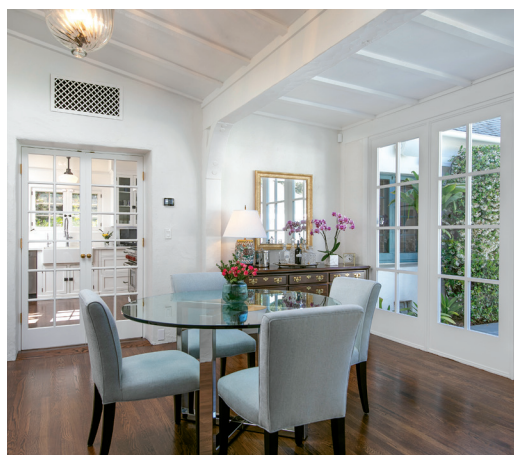
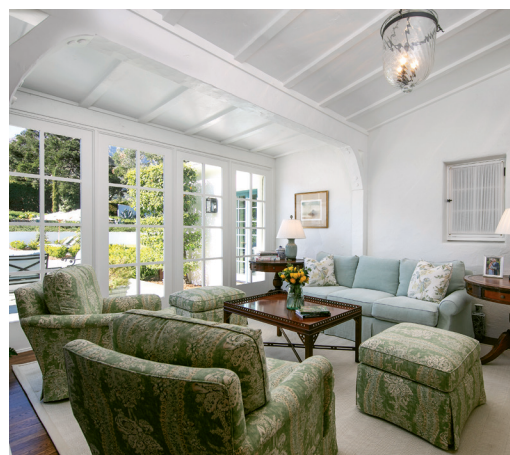
The project added new wood floors in the sunroom (near left) and east wing and refurbished the wall of French doors that open to the new pool, the garden and the mountains beyond them.

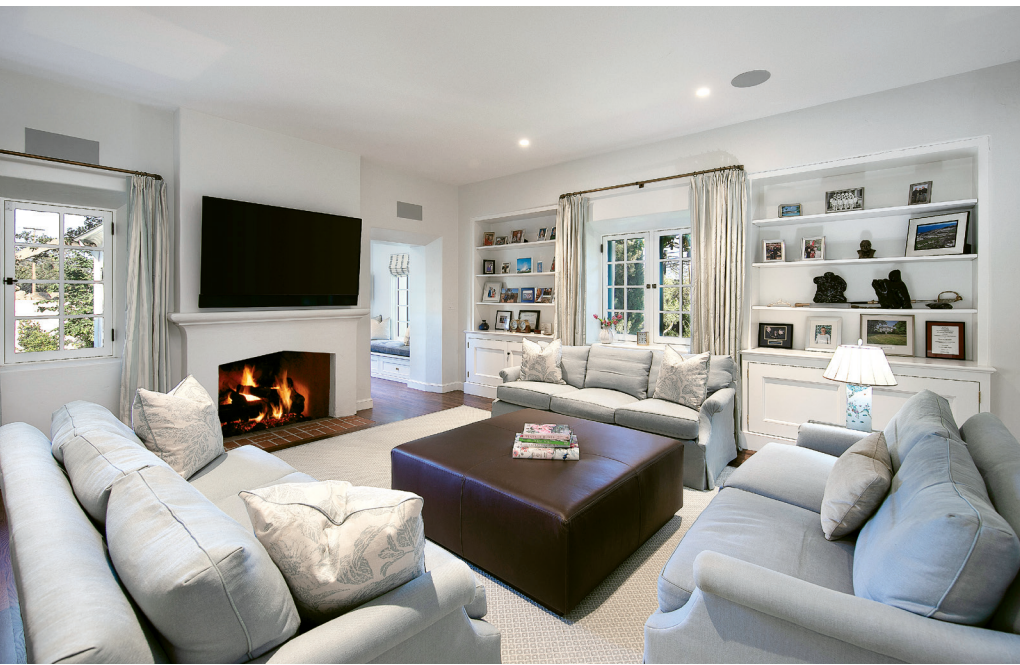
The building team raised the height of the windows in a small hallway between the relocated guest bedroom and media room (above) to allow for window benches. Built-in shelves adhere to Smith's original design.

"The home was built with 2 feet of airspace between the inner and outer wall construction that served as an insulator. Since we were super-insulating the exterior, that airspace became unnecessary. Once we opened it up, we decided to take advantage of the space," he adds. "So, we built into those areas and were able to add built-in bookcases, benches and other features."

window benches—rather than freestanding ones. The team also raised the height of the windows in a small hallway between the relocated guest bedroom and media room to allow for window benches. Built-in shelves were added to the new primary bedroom and guest room wing.

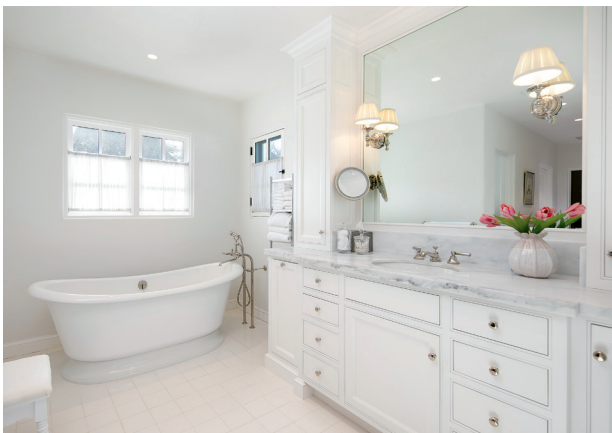
The team flipped the original primary suite (complete with sitting room and two separate baths with walk-in closets) to the back of the home.

The clients took the cards they had been dealt and capitalized on the opportunity to upgrade and enhance their historic home. They reconfigured the east wing, flipping the original primary suite (complete with sitting room and two separate baths with walk-in closets) to the rear of the home and replaced the former suite with a new media room, larger guest bedroom and two bathrooms.

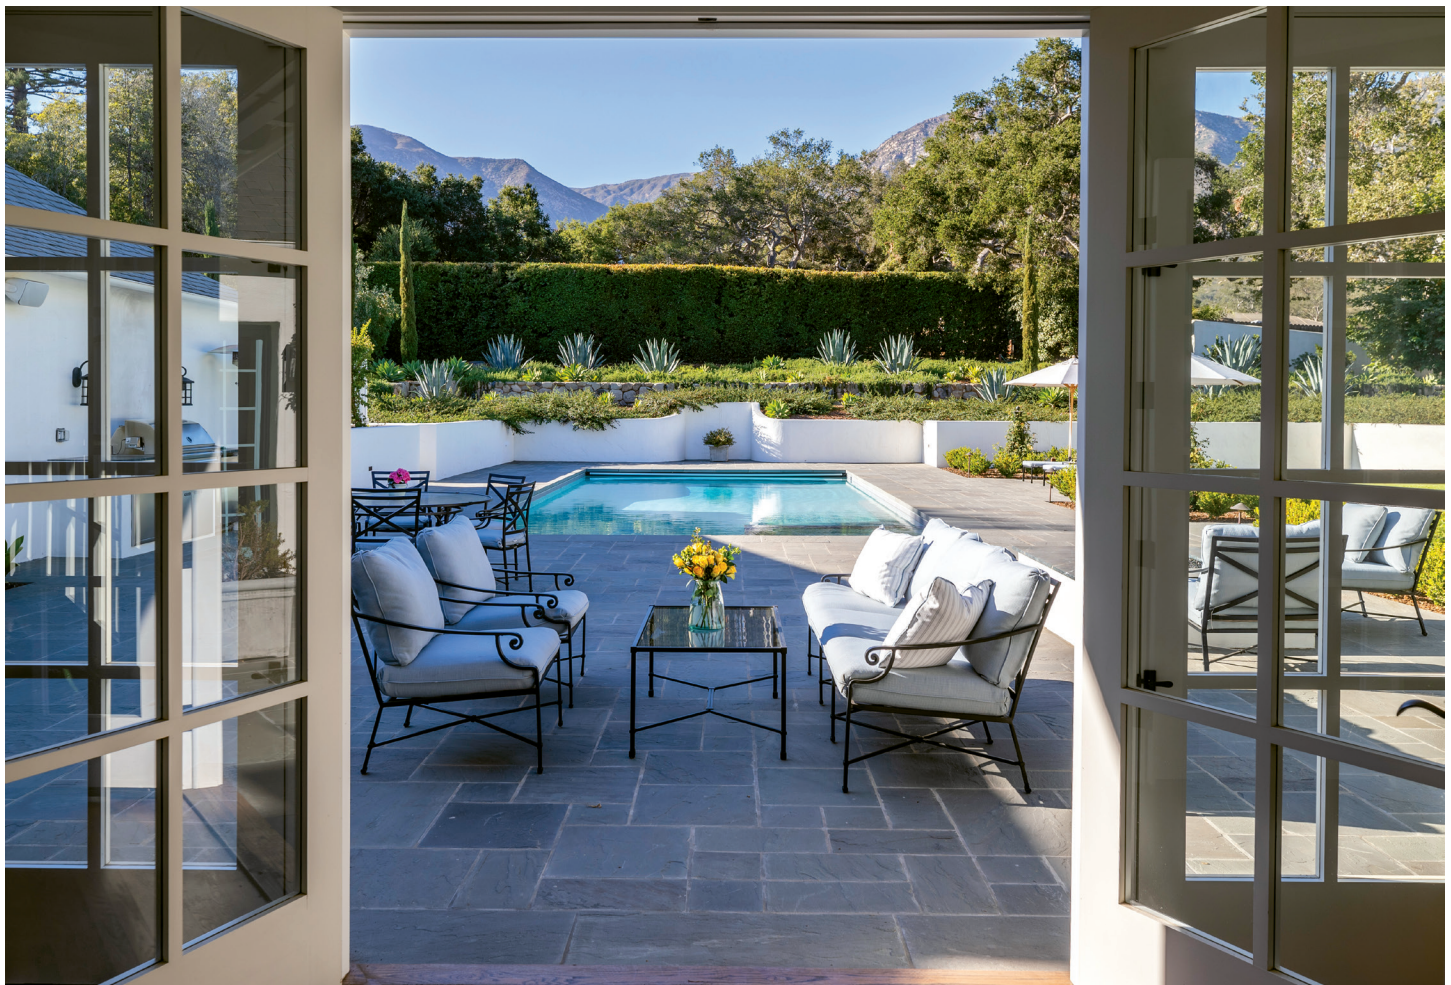
When a new pool was proposed, the building team recommended a plan to regrade the yard into one level (above), moving the retaining wall toward the rear of the property.

One of the most eye-catching parts of the property, the rear yard now includes the pool and a spa, fire pit, lounge seating and a small outdoor kitchen/barbecue. The building team added a reinforced retaining wall to the backyard to prevent future flooding and debris flow from the adjacent creek.

The original backyard consisted of a lower terrace adjacent to the existing house and an upper lawn, which were separated by a retaining wall with a central stairway between the two levels. The building team recommended a plan to regrade the yard into one level and make the pool, surrounding deck and planting beds the focal point. A wall of French doors on the refurbished sunroom offers spectacular views of the pool, garden with antique yellow roses, and the mountains beyond.

Cleaning out the home after the mudslide took about three months, he says. “We constructed a heavily reinforced wall [toward the rear of the property] to mitigate that happening again. In other words, the mudflow would’ve stayed outside had that barrier been there. And if it ever happens
